Environmental Isolation Must Be Carried out before the Construction

Abstract: Building isolation took care of the groundwater's constant level if it dropped, resulting in building cracking and even collapsing. Objective: without building isolation, ground subsidence causes cracks and befallen workers. The survey case study of houses near the project showed that the engineer did not understand mechanics. Novelty: Without building, isolation caused crashes in several homes near the project. Previous studies focused on human error, not using personal protective tools and lack of warning signs. Analysis of soldier piles without water-retain walls so that the dewatering process caused reduced groundwater and cracked divisions. Conclusion: The building was uninsulated during Construction, so groundwater was unstable, and the wall collapsed, befalling workers.

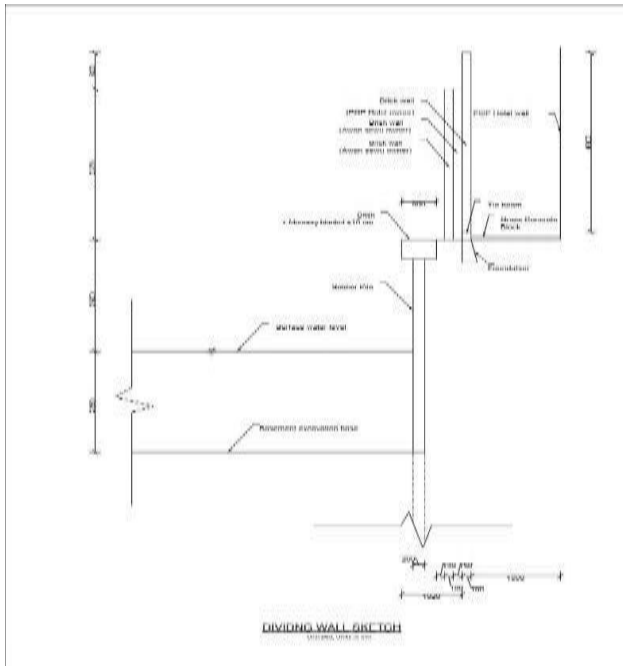
Figure 1. The fence wall collapse (source: Supervisor document)

1) The walls of the POP Hotel fences and the fence walls of residents' houses. The border was U-shaped with a height of 3.2 - 4 meters, surrounding the rear, left and right sides of the Awan Hotel building project. The fence wall of the POP Hotel consists of 3 layers two layers of the old wall, one brick thick without practical columns, and one layer of the POP Hotel guardrail wall half brick thick with functional columns.

2) At the time of the wall's collapse with a fall of 6 meters, pile cap work was being carried out at the location in the middle of the POP Hotel's dividing wall. Will collapse occurred in the old fence and was followed by the POP Hotel dividing wall. Cracks in the walls and columnar structures of the residents' houses on the right side and the back wall of the project fence during the execution of drilled piles and soldierpiles. Information from the groundwater monitoring consultant in the borehole is discarded.

3) The soldier piles were spaced apart so they were hollow, and no watertight walls were installed, causing the neighboring groundwater to drop.

4) Groundwater was continuously dewatered because there was a source of water. On the other side of the building, a neighboring well near the Awan Hotel project had dried up.

5) The ground level between the wall of the fence and the POP Hotel wall was 1.5 meters wide, down to 10 cm, and a cavity occurred.

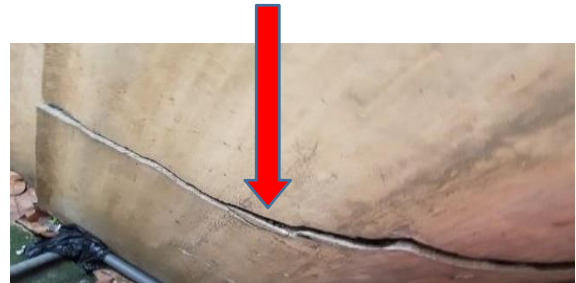
Figure 2 Back fence of the project, the boundary of the 1st resident's house (Source: Author document)

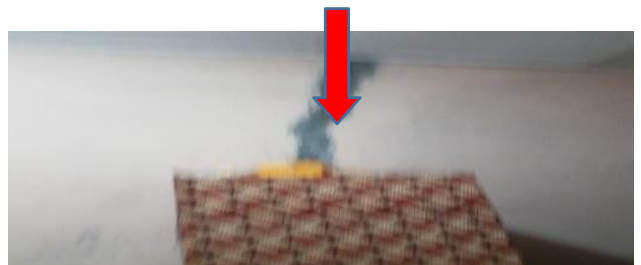
Figure 3. Cracked wall of the 1st resident's house (Source: Author document)

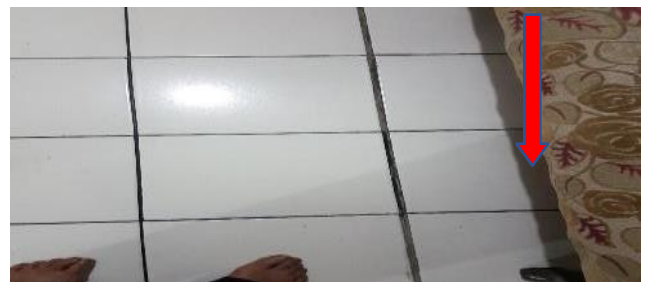
Figure 4. Slide floor of 1st resident's house (Source: Author document)

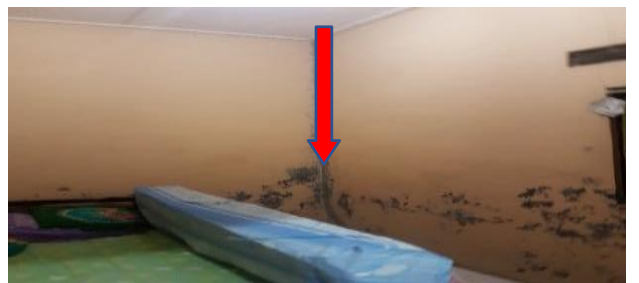
Figure 5. Wall-cracked restroom of the 1st resident's house (Source: Author document)

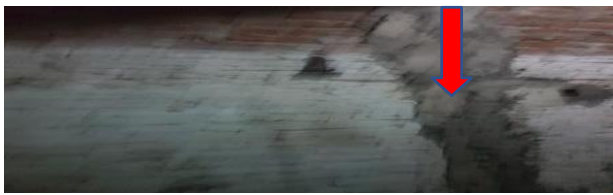
Figure 6. The wall of the 2nd house cracked, covered with plaster(Source: Author document)

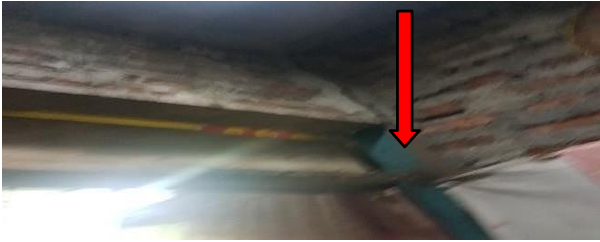
Figure 7. The wall of the 3rd house cracked(Source: Author document)

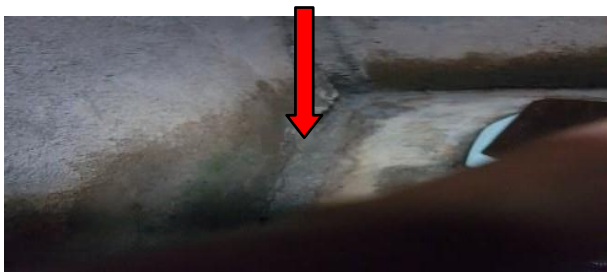
Figure 8. The floor of the 3rd house cracked(Source: Author document)
