Environmental Isolation Must Be Carried out before the Construction

Abstract: Building isolation took care of the groundwater's constant level if it dropped, resulting in building cracking and even collapsing. Objective: without building isolation, ground subsidence causes cracks and befallen workers. The survey case study of houses near the project showed that the engineer did not understand mechanics. Novelty: Without building, isolation caused crashes in several homes near the project. Previous studies focused on human error, not using personal protective tools and lack of warning signs. Analysis of soldier piles without water-retain walls so that the dewatering process caused reduced groundwater and cracked divisions. Conclusion: The building was uninsulated during Construction, so groundwater was unstable, and the wall collapsed, befalling workers.

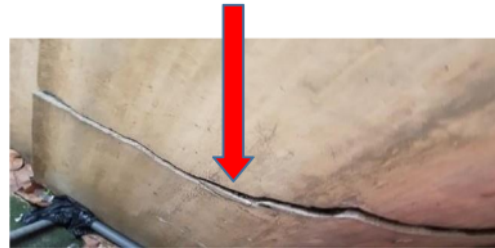
Figure 2 Back fence of the project, the boundary of the 1st resident's house (Source: Author document)

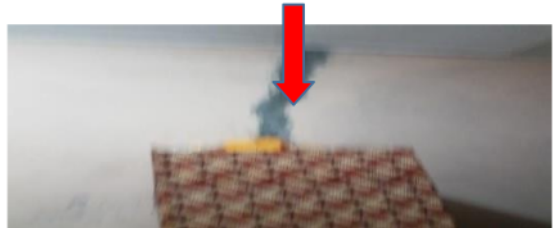
Figure 3. Cracked wall of the 1st resident's house (Source: Author document)

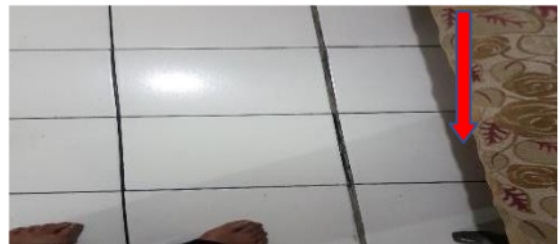
Figure 4. Slide floor of 1st resident's house (Source: Author document)

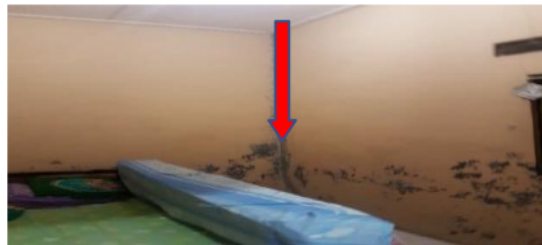
Figure 5. Wall-cracked restroom of the 1st resident's house (Source: Author document)

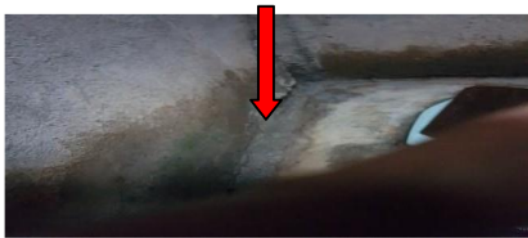
Figure 8. The floor of the 3rd house cracked(Source: Author document)
