# Environmental Isolation Must Be Carried out before the Construction

**Abstract:** Building isolation took care of the groundwater's constant level if it dropped, resulting in building cracking and even collapsing. Objective: without building isolation, ground subsidence causes cracks and befallen workers. The survey case study of houses near the project showed that the engineer did not understand mechanics. Novelty: Without building, isolation caused crashes in several homes near the project. Previous studies focused on human error, not using personal protective tools and lack of warning signs. Analysis of soldier piles without water-retain walls so that the dewatering process caused reduced groundwater and cracked divisions. Conclusion: The building was uninsulated during Construction, so groundwater was unstable, and the wall collapsed, befalling workers.

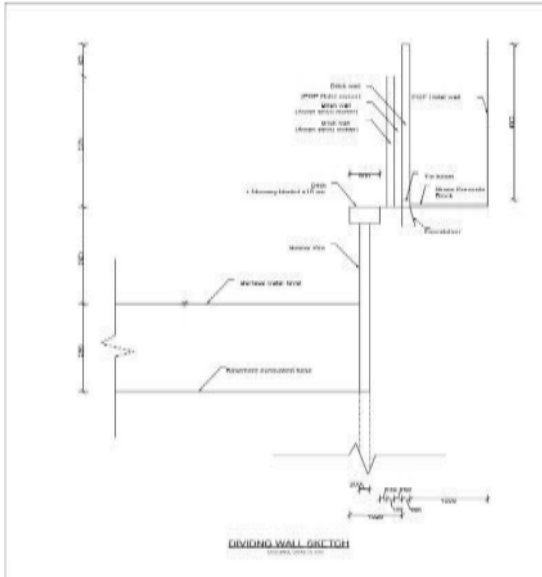
Figure 1. The fence wall collapse (source: Supervisor document)

1) The walls of the POP Hotel fences and the fence walls of residents' houses. The border was U-shaped with a height of 3.2 - 4 meters, surrounding the rear, left and right sides of the Awan Hotel building project. The fence wall of the POP Hotel consists of 3 layers two layers of the old wall, one brick thick without practical columns, and one layer of the POP Hotel guardrail wall half brick thick with functional columns.

2) At the time of the wall's collapse with a fall of 6 meters, pile cap work was being carried out at the location in the middle of the POP Hotel's dividing wall. Will collapse occurred in the old fence and was followed by the POP Hotel dividing wall. Cracks in the walls and columnar structures of the residents' houses on the right side and the back wall of the project fence during the execution of drilled piles and soldier piles. Information from the groundwater monitoring consultant in the borehole is discarded.

3) The soldier piles were spaced apart so they were hollow, and no watertight walls were installed, causing the neighboring groundwater to drop.

4) Groundwater was continuously dewatered because there was a source of water. On the other side of the building, a neighboring well near the Awan Hotel project had dried up.

5) The ground level between the wall of the fence and the POP Hotel wall was 1.5 meters wide, down to 10 cm, and a cavity occurred.

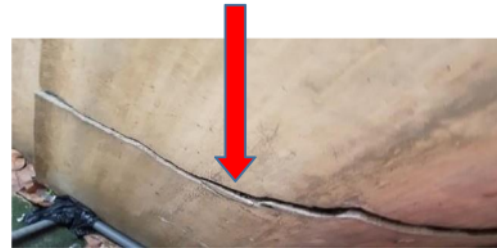
Figure 2 Back fence of the project, the boundary of the 1<sup>st</sup> resident's house (Source: Author document)

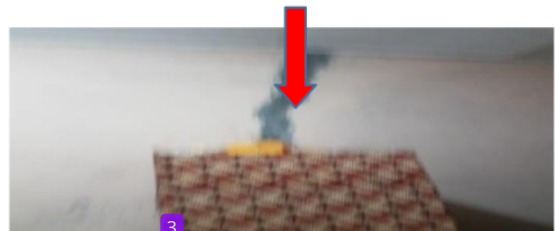
Figure 3. Cracked wall of the 1<sup>st</sup> resident's house (Source: Author document)

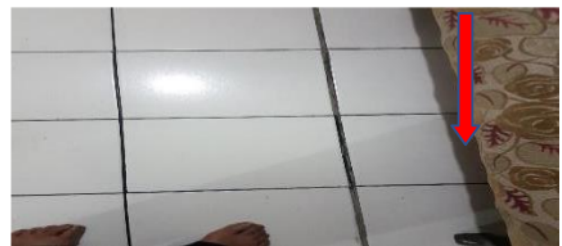
Figure 4. Slide floor of 1<sup>st</sup> resident's house (Source: Author document)

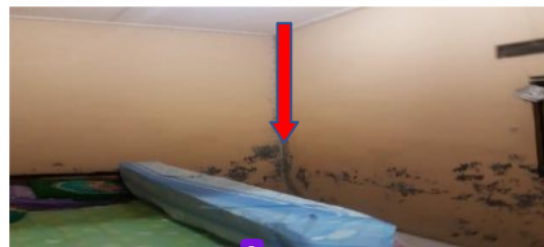
Figure 5. Wall-cracked restroom of the 1<sup>st</sup> resident's house (Source: Author document)

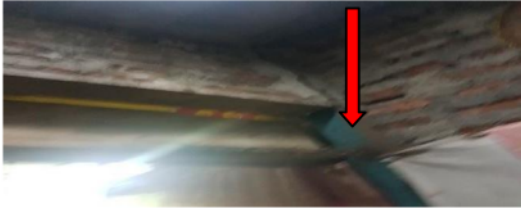
Figure 7. The wall of the 3<sup>rd</sup> house cracked(Source: Author document)

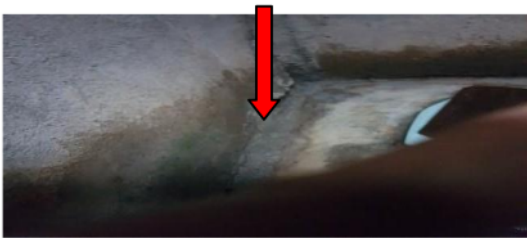
Figure 8. The floor of the 3<sup>rd</sup> house cracked(Source: Author document)
