RETROFITTING ANALYSIS OF STEEL ROOF FRAME TO PRESERVE HERITAGE BUILDING 1921

The spirit of preserving heritage buildings as they originally became a big challenge during design analysis to remain original state, with no damage construction process. The objective of this research was to maintain the authenticity of the structure. roof covering. strengthening and detaching the roof, by analyzing the structure on the strength, stability, and deflection of the roof with Indonesian code 1729-2015 based on the American Steel concept. Analysis of dead loads, live loads, and the wind load, because only the roof was on the 3rd floor and the roof slope is 30°. The case study method was carried out with surveys and secondary data results from the investigation consultant in 2016. The results of the analysis of two guss members' roof 2L 70.70, need to be replaced with a double profile 2L 80.80, bolt connections with the provision that steel profiles, bolts, and rust anchors were replaced. Analysis of the 3-dimensional roof structure with software by calculating the compressive wind load of 75.82 kg/ m², and the suction wind load of 57.37 kg/m² according to the wind speed of 40 m/s. Conclusion

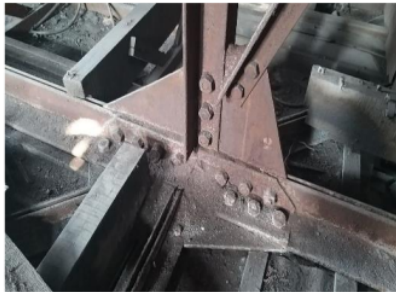
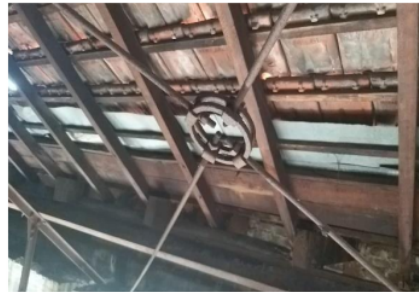
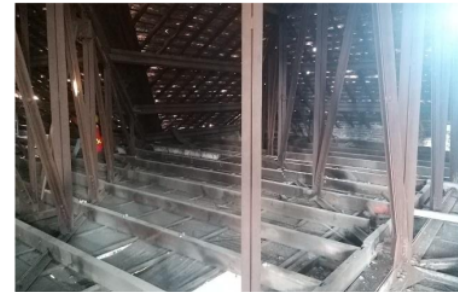
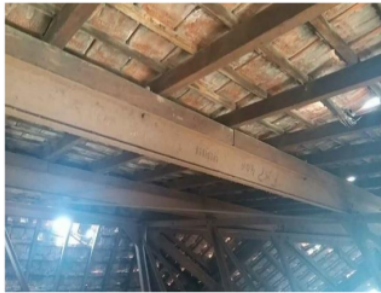
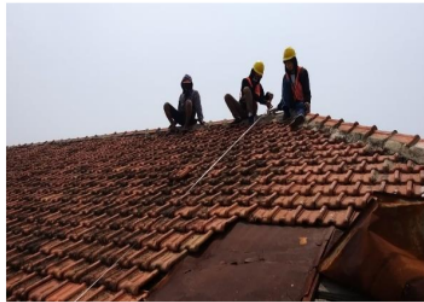
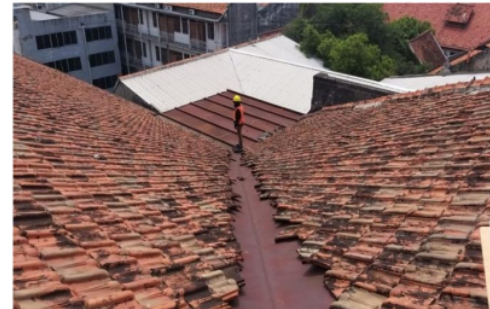
238 Figure 11 a,b,c,d,e,f,g Existing Detail Roof Structure and Roof

240 The facade must be retained like its original form, as well as the details of the roof
241 knick-knacks are also made as before, namely bolt connections made according to
242 the supporting structure, namely bracing, ceiling hangers, roof beams, roofs, and

243 gutters, the principle is even though the roof structure strengthened by replacing the
244 porous and damaged but the shape of the roof, the structure of the roof and the
245 details are retained

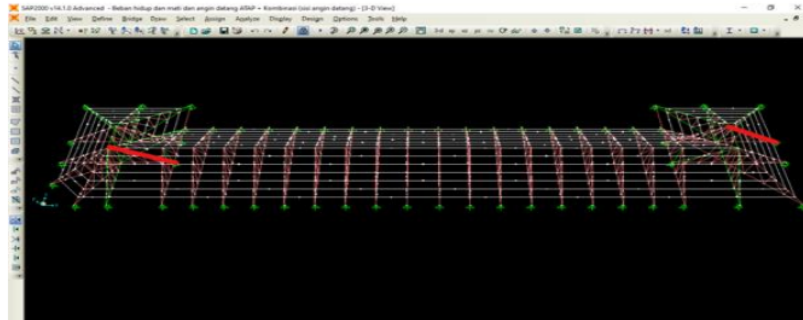
284
285 Figure 12. Two profile members 70.70.7 need to be replaced with double elbows
286 80.80.8. Two profile members 70.70.7 need to be replaced with double elbow
287 80.80.8 on type K2 as per figure 16

275 bolts 2 pcs (existing installed 3 bolt) on the 2L 80.80 profile, 3 pcs on the 2L profile
276 70.70, 2 pcs on the 2L profile 60.60, 2 pcs on the 2L profile 50.50, 2 pcs on 2L
277 40.40 profile and 4 anchors. With a deflection of 0.25 cm at a distance of 7.4 m
278 and a distance of 4.1 m roof truss obtained a deflection of 0.11 cm.
279 Of the many elbow profile on the roof truss and curtain beam, the results of the
280 computer output show that 2 members exceed the stress limit so the dimensions that
281 need to be enlarged from the existing 70.70.7 profile dimensions of the double
282 elbow can be seen in the image below:

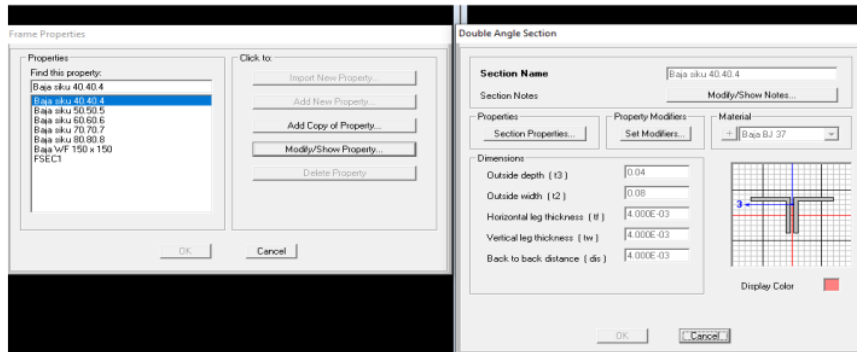
Sources Researcher Team: Input of SAP2000 Program Figure 22 Dimension of steel material double elbow

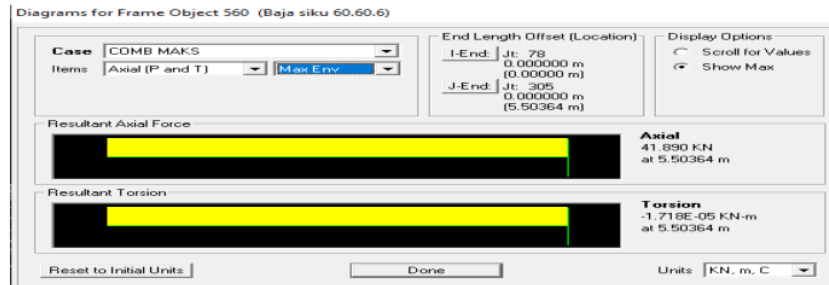
400
401 Figure 25 Axial force. Double elbow steel profile 60.60.6 L 5.44256 kN tension

396 1. Double elbow steel profile 60.60.6 Member no 560 Span L- 5.50364 P max elbow
397 60.60.6 member no 426 output software = 41,89 kN, yes it safe

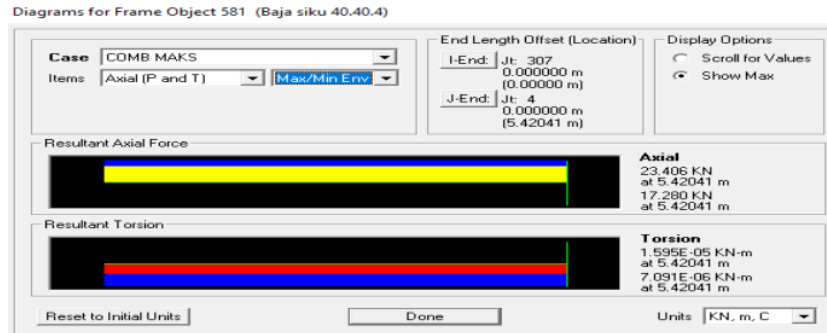
414 **Figure 27: Axial force. Double elbow steel profile 40.40.4**

409 Double elbow 40.40.4 Member no 581 biggest force
 410 P max elbow 40.40.4 output software = 23.41 kN, yes it safe
 411
