Solid State Technology
Volume: 63 Issue: 6
Publication Year: 2020

Analysis of Floating Seal Damage Due to Over Travel against the Performance of a Reduction Excavator Motor Traveler

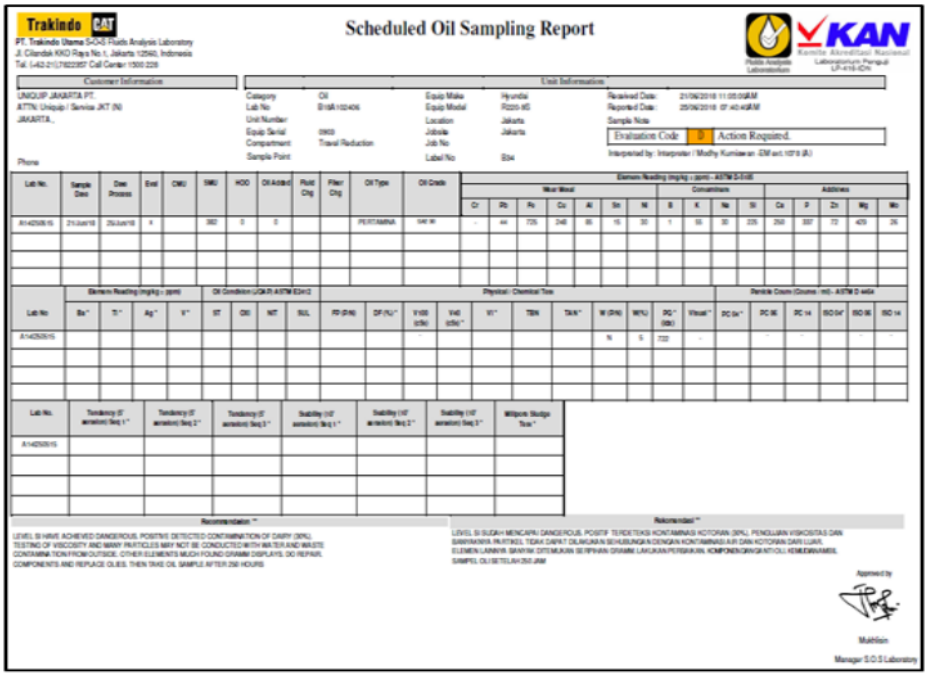
Fig 4. Used oil inspection results

A. travel motor reduction lubricant oil sampling for further testing in the laboratory. From the results of sampling found the presence of metal debris in the sample of the lubricating oil and the color of the lubricating oil is black. Based on the results of laboratory tests it is known that oil has decreased in quality where the value of Si and other substances has reached a dangerous warning and positively detected have been contaminated with dirt by (30%). For viscosity testing of lubricating oil can not be done because it has been contaminated with impurities from the outside and also water mixed with lubricating oil. Lubricating oil in this case is included in the D (bad) category.

LEVEL SI HAVE ACHIEVED DANGEROUS, POSITIVE DETECTED CONTAMINATION OF DIRTY (30%), TESTING OF VISCOSITY AND MANY PARTICLES MAY NOT BE CONDUCTED WITH WATER AND WASTE CONTAMINATION FROM OUTSIDE. OTHER ELEMENTS MUCH FOUND GRAMM DISPLAYS. DO REPAIR COMPONENTS AND REPLACE OLIES. THEN TAKE OIL SAMPLE AFTER 250 HOURS

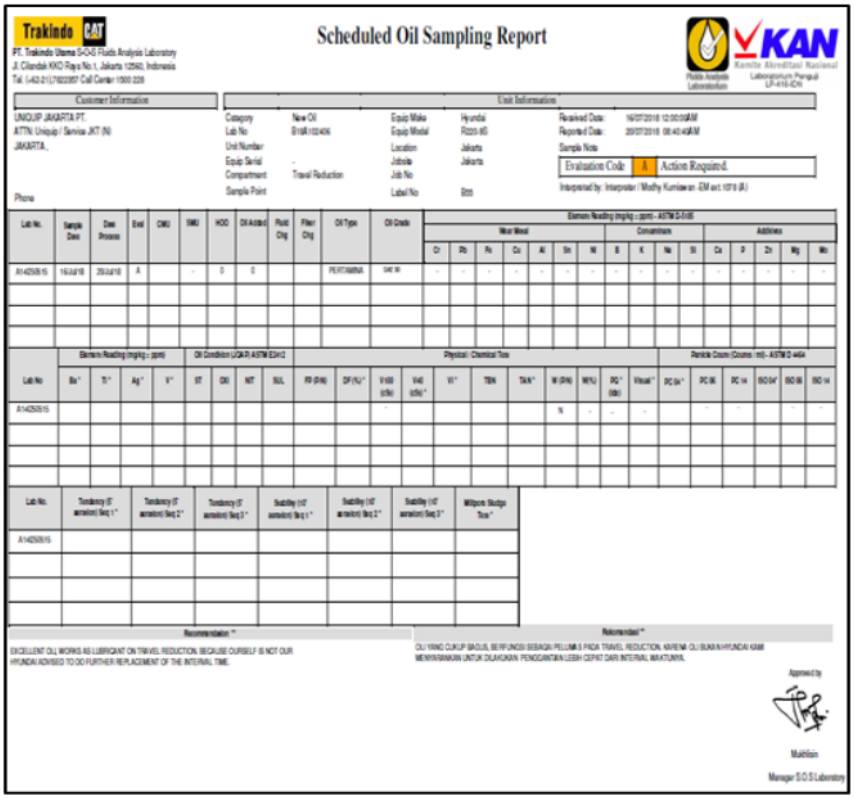
Fig 5. New oil inspection results

EXCELLENT OIL WORKS AS LUBRICANT ON TRAVEL REDUCTION, BECAUSE OURSELF IS NOT OUR HYUNDAI ADVISED TO DO FURTHER REPLACEMENT OF THE INTERVAL TIME.

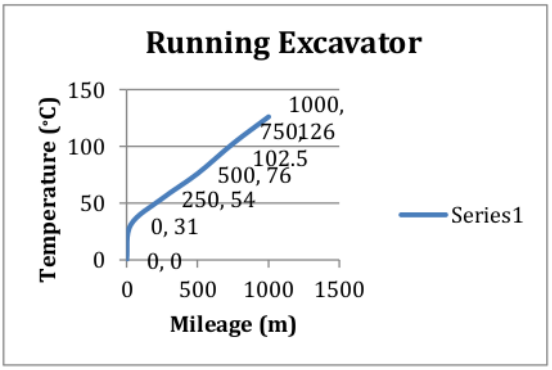
Fig 15. Graph of the relationship between distance and temperature on a travel motor

From the results of the excavator operation test above, the reason for testing is based on traveling excavator data obtained from Hi-mate. From these data it is known that the excavator traveling exceeds the recommended travel limit in accordance with the operating procedure based on Oepration Manual Maintenance (OMM).

Based on data from the table, it is known that floating seals can be used well at temperature limits between 25 0C to 100 0C. From the results of direct testing and compared with data from Hi-mate it can be seen that the cause is overheat based on the test data obtained from the temperature value of 125 0C which exceeds the limit of temperature resistance of floating seal material made of NBR rubber type at temperatures of -25 to 100 0C which causes the floating seal component to be abrasive until it is destroyed which results in leakage and dirt entering the travel motor reduction section so that the lubricating oil that has been damaged by burning plus added to the dirt from the outside and also the dirt from the floating float seal. The results of laboratory tests said that lubricating oil has deteriorated where the lubricating oil is damaged due to the influence of tempratur and also many external elements that enter the lubricating oil.
